SHIVERS AND STUMBLES

PUMPED OUT MPV

VEHICLE: 1993 Mazda MPV Van
POWERTRAIN: 2.6L four-cylinder with four-speed automatic transmission
MILEAGE: 112,842
COMPLAINT: Intermittent hesitation and stalling.

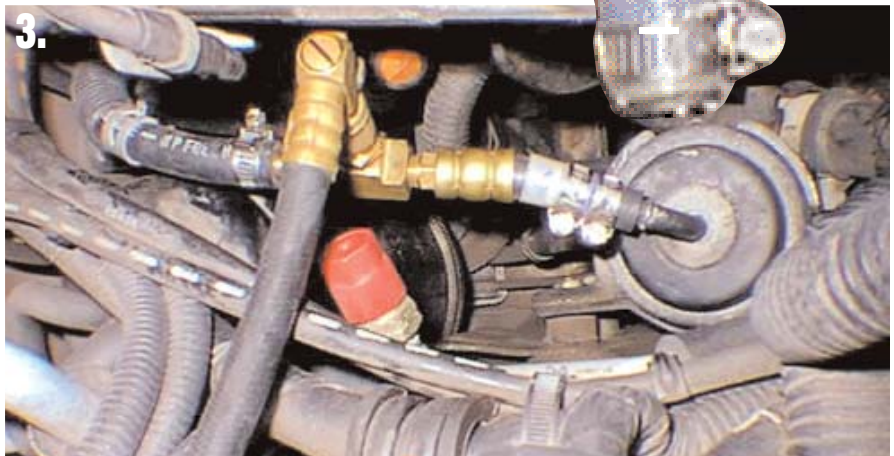
3. Having this adapter installed makes fuel pressure testing a snap. It would be nice if all cars had a Schrader valve built on the fuel line.

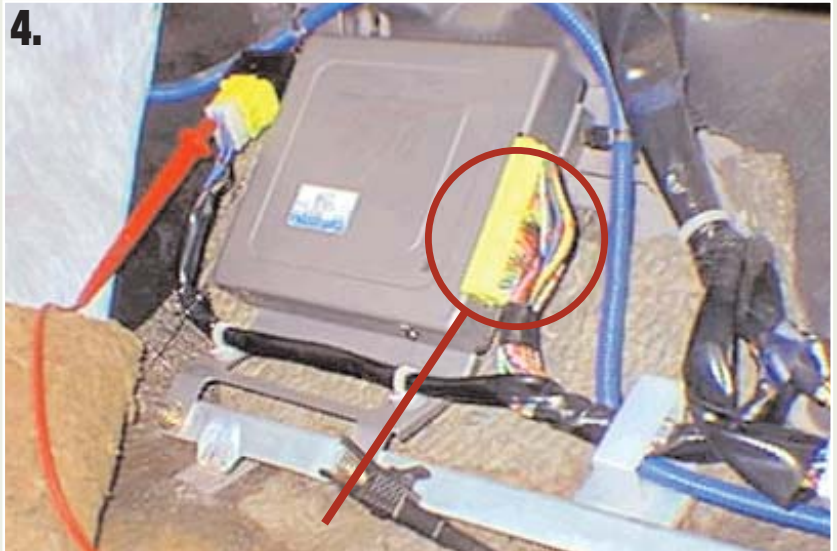
4. You can easily access the ECU and COR relay with the right front rug pulled back and the protection plate removed. You can see that I have back-probed the blue supply wire to the fuel pump.

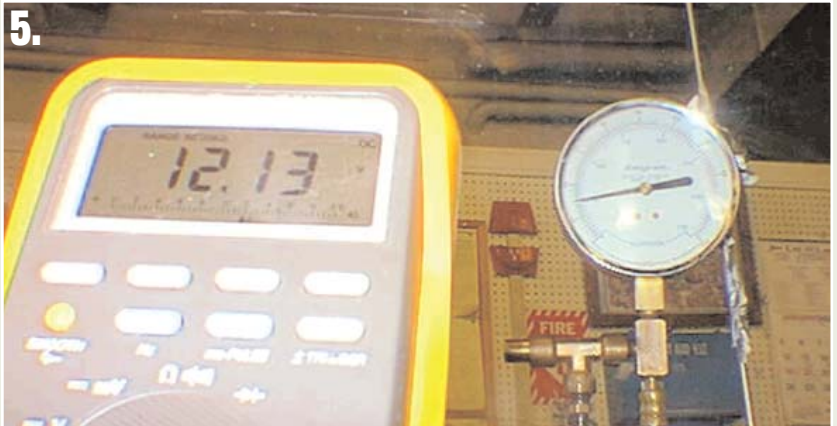
5. Finally the intermittent problem rears its ugly head. The fuel pump's supply voltage is solid and steady, but fuel pressure is taking a dive.

“After another two test drives the car was finally hesitating. The fuel pressure dropped to 12 to 18 psi and the fuel pump voltage remained a constant 12.4 volts.”

After another two test drives the car was finally hesitating. During these events, the fuel pressure dropped to 12 to 18 psi and the voltage to the pump remained a constant 12.4 volts. Even though all the variables had not been eliminated, our tests pointed to an intermittent fuel pump problem. Obviously, the best diagnostic test would be to hook up power and ground test leads as close to the pump as possible. A fuel pressure volume test and an amp draw test can be performed as well. Given a busy day's time constraints combined with this industry's escalating labor cost per hour, it is often more acceptable to perform tests at a remote, more accessible location, hence the method to my madness. As a final protective measure we installed a new fuel filter. It was a good thing we looked up the procedure to change the fuel pump; otherwise, we would have dropped the tank for nothing. As typical with Asian engineering, the pump access plate is located within the cabin under the #2 seat.

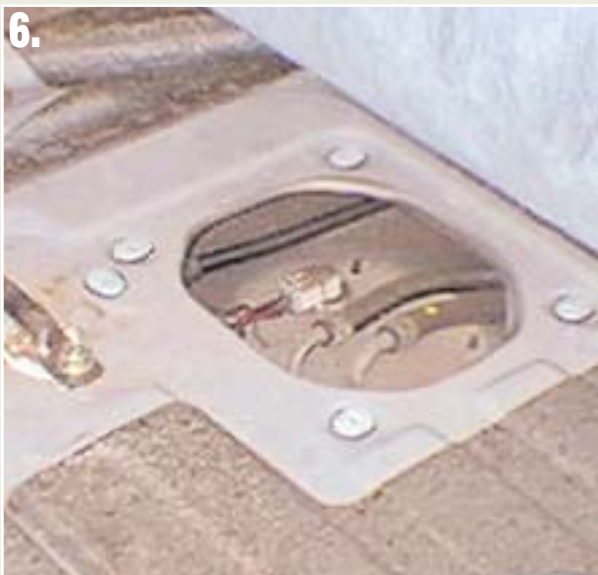
6. One of the easier fuel pump access locations in the normally difficult and complex world of automotive repair.
