SHIVERS AND STUMBLES

PUMPED OUT MPV

VEHICLE: 1993 Mazda MPV Van
POWERTRAIN: 2.6L four-cylinder with four-speed automatic transmission
MILEAGE: 112,842
COMPLAINT: Intermittent hesitation and stalling.

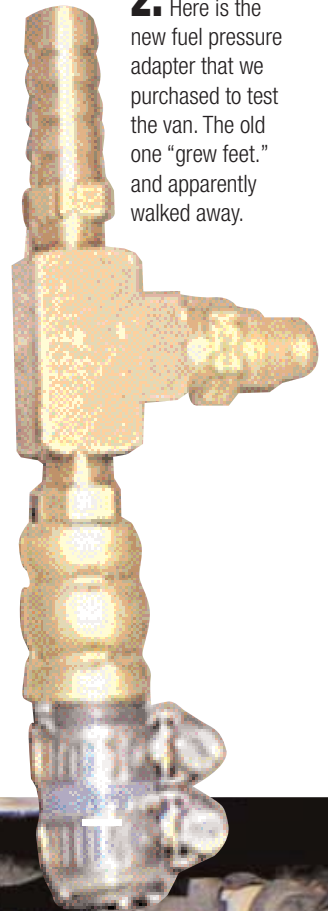
2. Here is the new fuel pressure adapter that we purchased to test the van. The old one "grew feet." and apparently walked away.
